Harrison Home Inspections Property Inspection Report

Your Address Here, Baltimore, MD 21224 Inspection prepared for: Your Name Here Real Estate Agent: -

Date of Inspection: 8/11/2022 Time: 4:30 PM Age of Home: 1963 Size: 2007

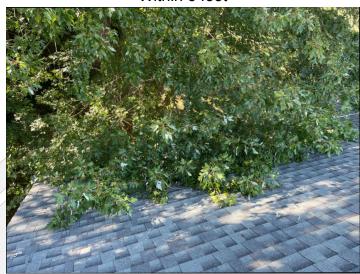
• There are large trees above house. The trees appear healthy at time of inspection. Recommend monitoring for dead branches and trim as necessary.

Limbs touching roof

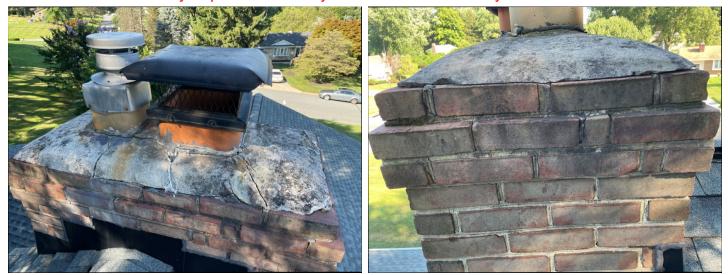
Observations:
Some mortar deterioration observed; recommend repair as necessary.
Chimney Crown shows signs of deterioration. Recommend having repaired by a gualified chimney contractor as necessary.

Cracked

Mortar deterioration

Page 17 Item: 3	Chimney	• Chimney Crown shows signs of deterioration. Recommend having repaired by a qualified chimney contractor as necessary.

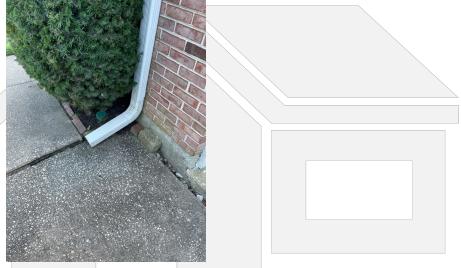
• Downspout drains onto sidewalk / driveway. Recommend exploring ways to divert water away from this area, or at the very least, recognize this as a potential ice hazard; use ice melt products and exercise caution.

Drains to driveway

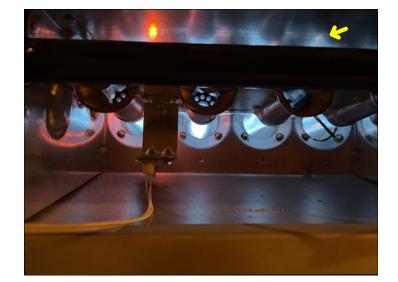
• Fuel Furnace: Last service date is over one year ago, or is unable to be determined. There are areas which cannot be seen without specialized equipment and training. One such area is the combustion chamber / heat exchanger where cold air blows across the "fire box", becoming the hot air that circulates throughout your home. During the life span of any furnace, this metal wall may develop a crack or a broken weld, allowing carbon monoxide to circulate throughout the home. This is why furnace specialists recommend a complete inspection annually; recommend having unit inspected by certified HVAC technician.

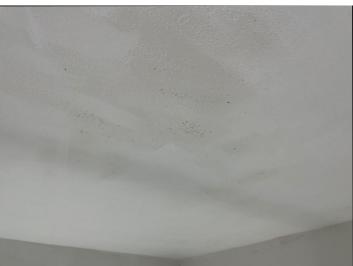
• Biological growth present in some areas. Recommend having cleaned and treated as necessary.

Upstairs hall bath: biological growth

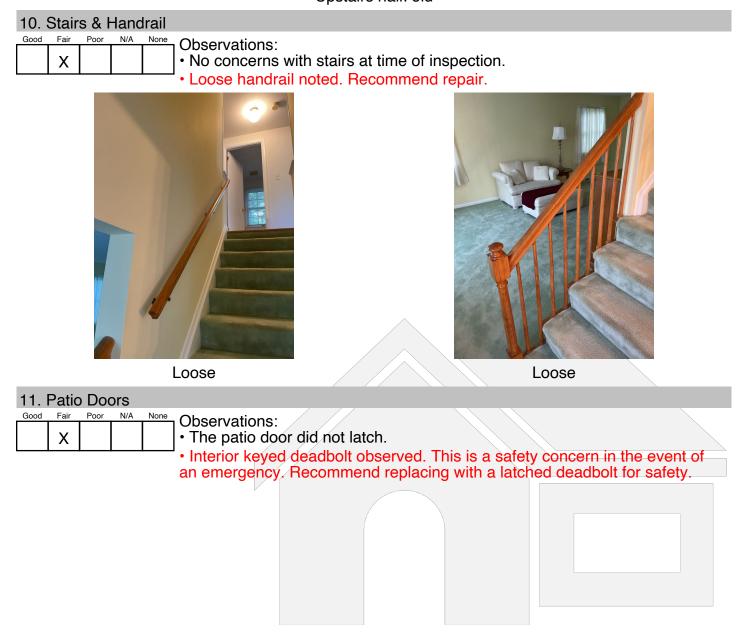
Laundry room: Interior keyed deadbolt

Page 47 Item: 10	Stairs & Handrail	Loose handrail noted. Recommend repair.
Page 47 Item: 11	Patio Doors	• Interior keyed deadbolt observed. This is a safety concern in the event of an emergency. Recommend replacing with a latched deadbolt for safety.

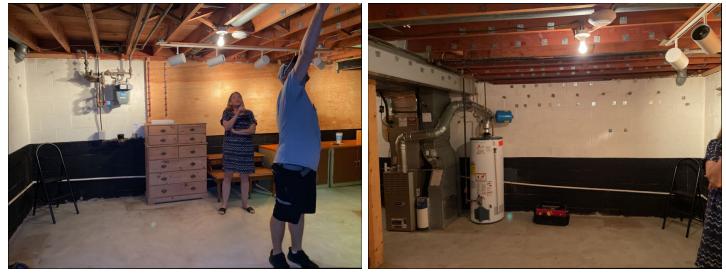
• Efflorescence observed; this is a mineral deposit left behind from previous exterior water infiltration.

Efflorescence

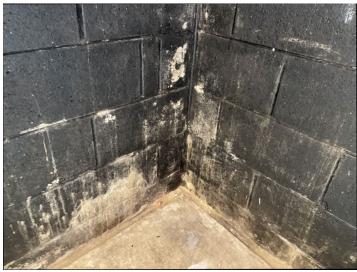
Staining

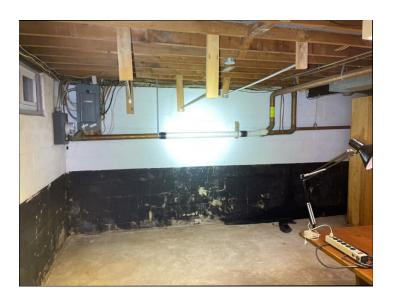
High moisture level
