Harrison Home Inspections Property Inspection Report

Your Address Here, Baltimore, MD 21224 Inspection prepared for: Your Name Here Real Estate Agent: -

Date of Inspection: 8/11/2022 Time: 4:30 PM Age of Home: 1963 Size: 2007

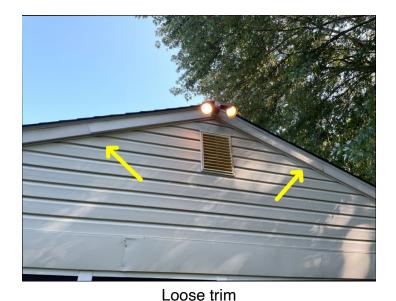
Loose trim

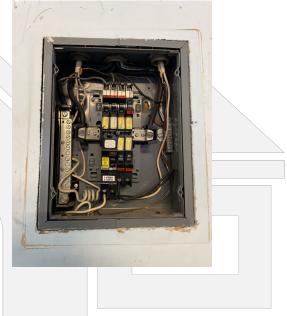
Page 18 Item: 1 E	Electrical Panel	Double tapped breaker(s) inside panel box (more than one
		 electrical conductor attached). This is not standard practice, and may cause overheating or even an electrical fire. Recommend evaluation by an electrician. There is a Federal Pacific Electric service panel in the house. There are studies that show that some FPE circuit breakers are prone to problems that can lead to failures, lack of proper protection of circuits and other serious issues, including fire and electrocution. Although the Consumer Products Safety Commission has not issued a formal product recall, the panel is old and the company is now out of business. We cannot definitively call this panel defective, but recommend, for your peace of mind, to consult a qualified electrical contractor to get their opinion on this matter. You can learn more about this issue at: www.inspect-ny.com/fpe/fpepanel.htm Aluminum wiring present—Between 1965 and 1973, aluminum wiring was sometimes substituted for copper wiring in residential electrical systems. Connections in outlets, switches, and light fixtures with aluminum wiring become increasingly dangerous as time passes. Poor connections cause wiring to spark and overheat, creating a potential fire hazard. The wiring should be evaluated by a qualified electrician experienced in evaluating and correcting aluminum wiring), oxidation (caused when electric currents pass through wiring), oxidation (caused by exposure to oxygen in the air), and galvanic corrosion (caused when two different metals are connected together), all of which can cause poor connections. When wires are poorly connected they overheat, which creates a potential fire hazard.

Double tapped

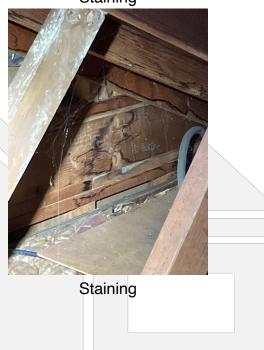
Staining

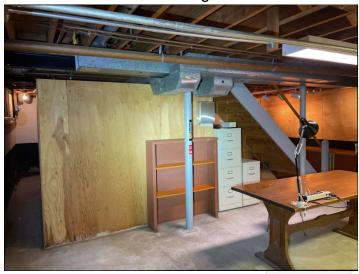
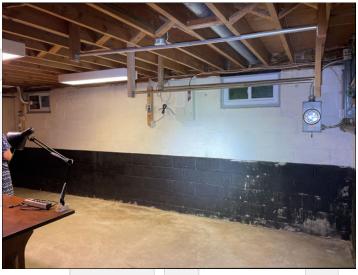
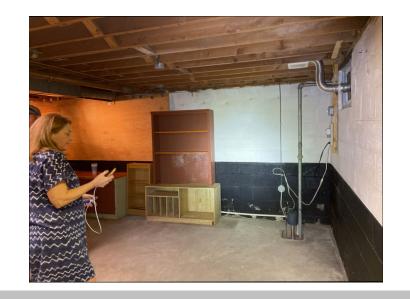
Page 64 Item: 13	Counters	 Countertop is loose at cabinets in one or more locations. Recommend repair as necessary 			
Basement	· · · · · · · · · · · · · · · · · · ·				
Page 65 Item: 1	Foundation/Walls	• There were signs of water penetration at foundation wall. Recommend conferring with seller as to any past moisture problems and have evaluated by a qualified basement waterproofing specialist.			
L

High moisture level
